# INTEGRATED MANAGEMENT OF WATER RESOURCES IN BERCA VILLAGE, BUZAU COUNTY

#### Abstract

*Key words*: integrated water management, natural water bodies, water supply system, wastewater, sludge management, public health.

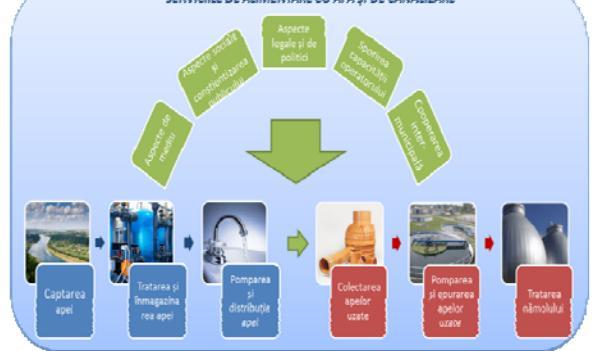
Figure 4. Approach for integrated management of water resources

must cover the full cycle of water use - from capturing and treating raw water, distribution of treated water, wastewater collection and discharge of treated wsstewater into natural bodies of water, and issues associated with the provision of sustainable water supply and sanitation, as shown in the figure below.

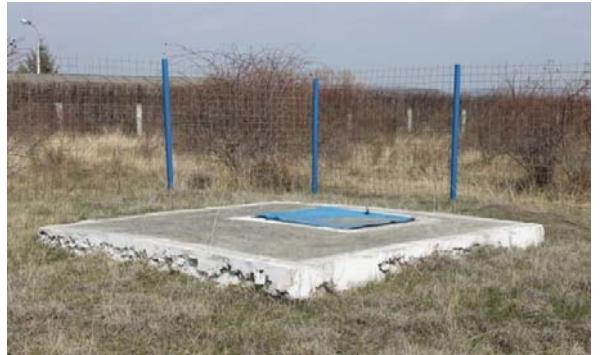
Figure 5. Drilling area

-Wells in the area Vernesti, which has 10 medium depth drilling wells, completed at a depth of 150-153 m each, and located north of Vernesti village, on the right side terrace of Buzau River, upstream of the confluence with the Niscov stream.

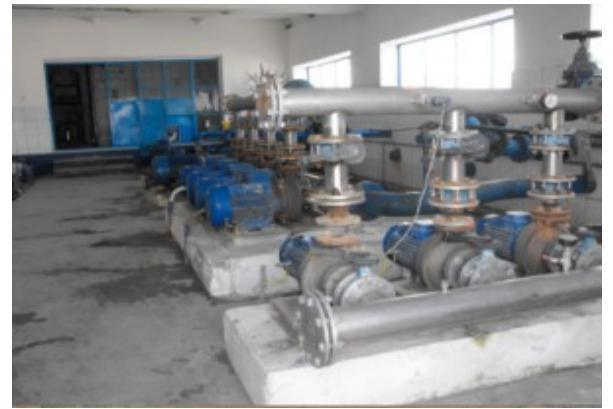
Figure 6. Vernesti pumping station

The pumping station Vernesti is placed in a brick building with the following destinations: pump room, board room, warehouse, workshop, dressing room, transformer station.

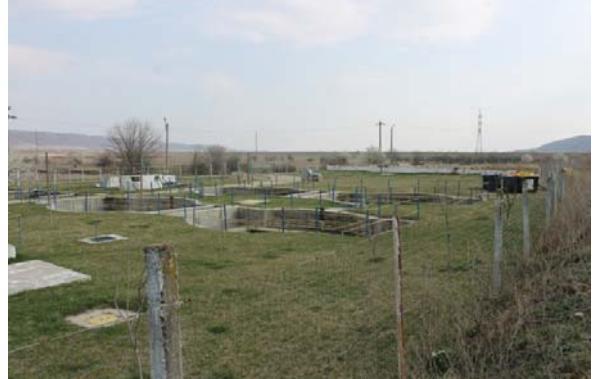
Figure 7. Berca WWTP

Rainwater collected from a network of gullies street of the village, is taken from a rainwater collector wich works gravitational with directly discharge into the River Buzau. The wastewater treatment plant is located on the left side of the River Buzau, in the village Plesesti, on an area of 5,200 square meters, and serves Berca commune.

The components of existing wastewater treatment plant are: grill withdesander, grease separator, flowmeter, primary sedimentation tanks, aeration basin, secondary sedimentation tanks, mud pumping station, chlorine contact basin, mud drying platform.

The existing sewerage system presents deficiencies inoperation, such as:

-sewage and stormwater systems from Berca should be in a separate system, but actually work in some areas, as an unitary system, so in the wastewater treatment plant arrives also stormwater, and in addition in different areas thesewerage is undersized.

-the existing wastewater treatmentplant works without biological stage, leading to overcoming the conditions imposed to treated wastewater discharge into the River Buzau.
